Subject: Re: Curvex Duchess 1937 520

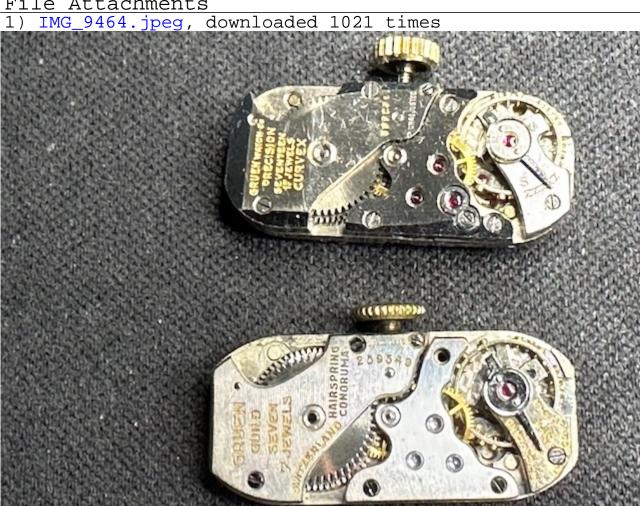
Attached is a photo of both the 520 (top) and 329 (bottom) movements. The 520 has the balance cock and balance from the 329 installed and is running great. The broken staff 520 balance cock and balance are installed in the 329. The upper bridges on the 520 have a cylindrically machined surface to fit the curves case.
