Subject: Re: stainless steel Curvex

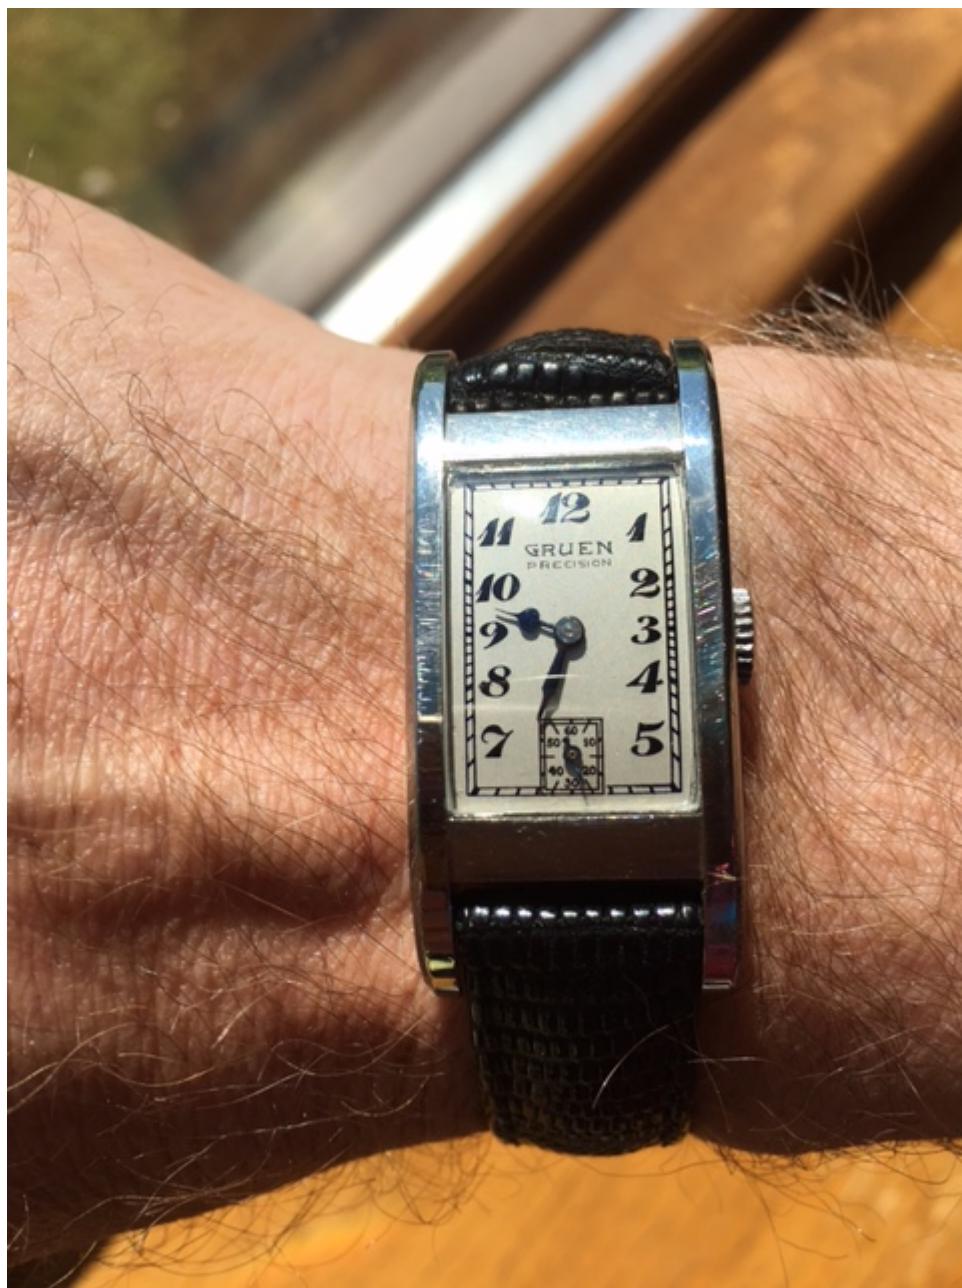
1) [Finished.JPG](#), downloaded 1786 times

I finished this watch this weekend.

The spare cal 311, that came with the dial, I thought would at least be good for spare parts. It was a good purchase. So, I finally sent the dial to Kirk Rich of California. After much discussion with them, it was decided that the numbers and minute track were original; they were fired-on enamel. What wasn't correct was the subseconds bit, the font for Gruen and the lack of the word "Precision". These were just contact prints. I've seen a few other early-ish 311 Curvex's that did not say "Curvex" on the dial. I can always add it later if needed, likely was over the seconds bit as it was. I'm a bit disappointed in the small section where the minutes track is disconnected from the edge of the seconds track. It is what it is... But after rather exhaustive research on this one, I think that this is what the original dial looked like; or darn close. I did not have "Switzerland" placed at the bottom.

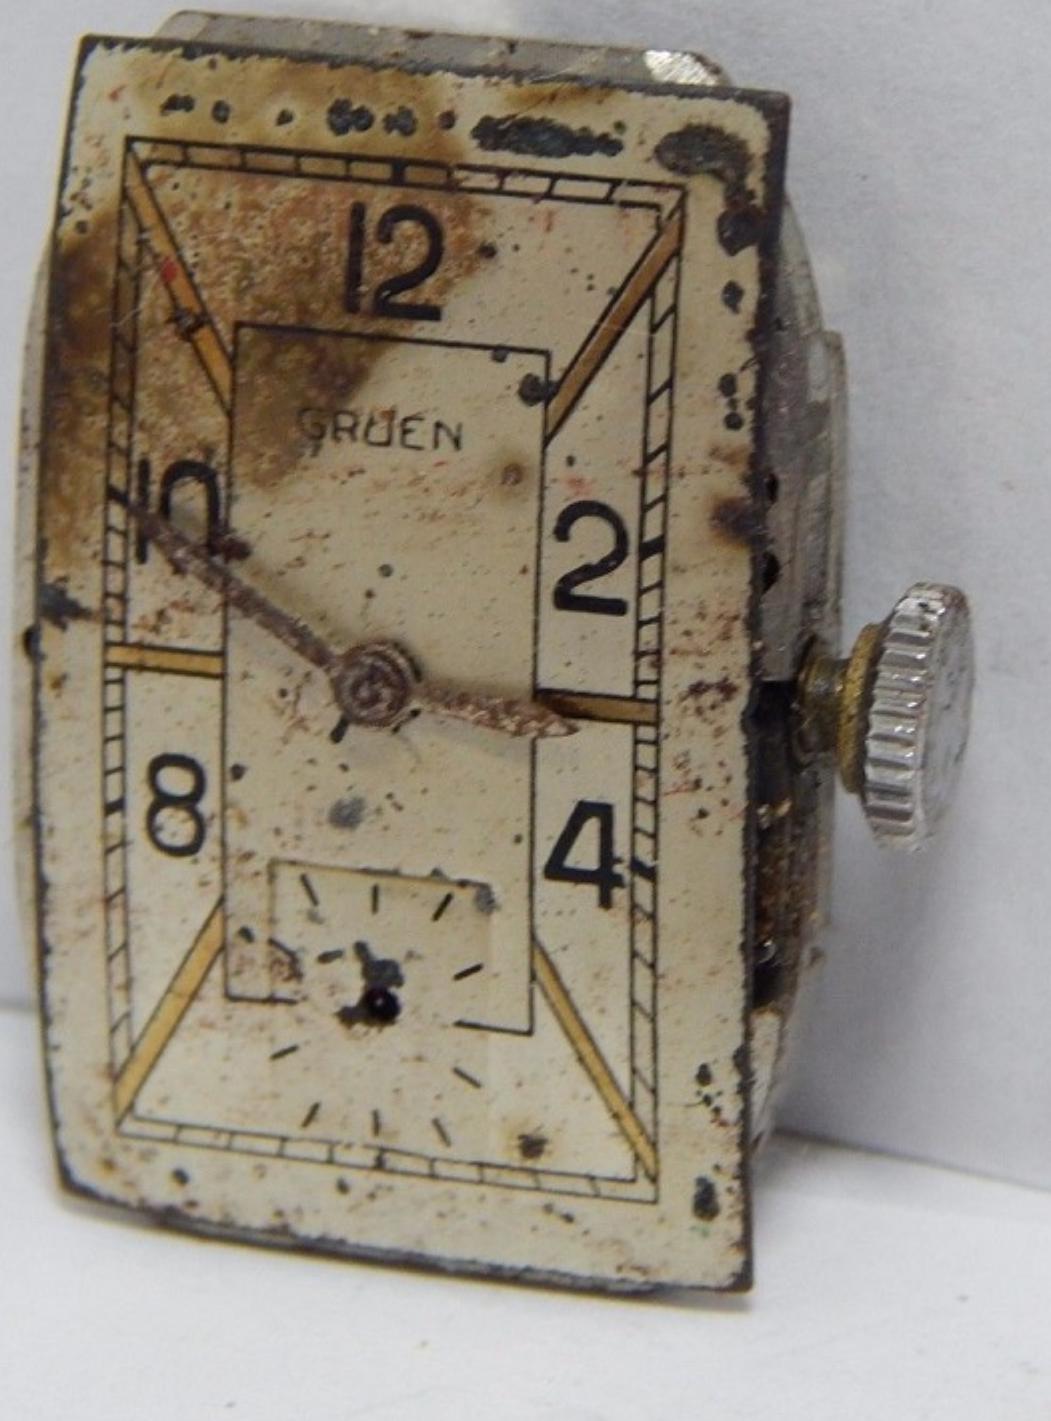
2) [other dial.jpg](#), downloaded 1774 times

I took my time on this one... the dial was a major concern to me. I even tracked down a different dial based on some pictures from afire and Cary.

...but it didn't fit.
