## Subject: Fully restored all-Swiss watch with 24-hour dial Posted by JackW on Mon, 14 Dec 2015 02:26:53 GMT

So... Early Pan American styled watch in chromed basemetal bezel with stainless steel (Guildite) back.

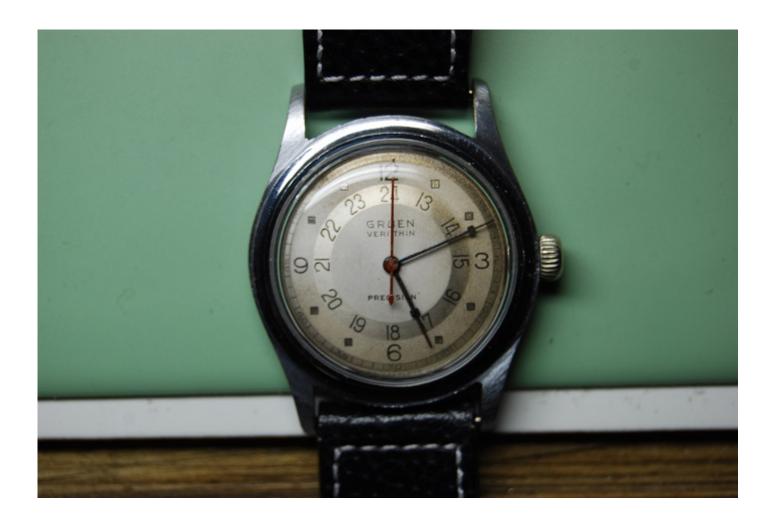
1) Pan Am\_dialside.jpg, downloaded 2906 times

Dial shows some minor loss on the details in the seconds track and the hands show signs of exposure to moisture. To be upfront the movement was pretty rusty but cleaned up well and what couldn't be cleaned was replaced. Specifically the setting bits and the ratchet wheel.

Movement has been overhauled, including restaffing the balance, and a new white allow mainspring. Runs with good amplitude and low error.

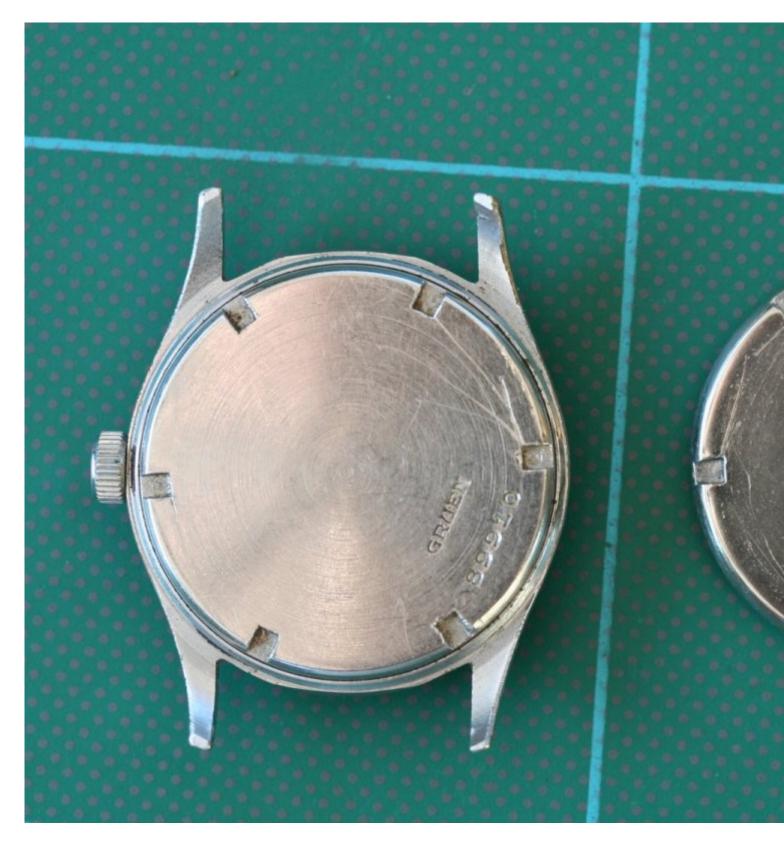
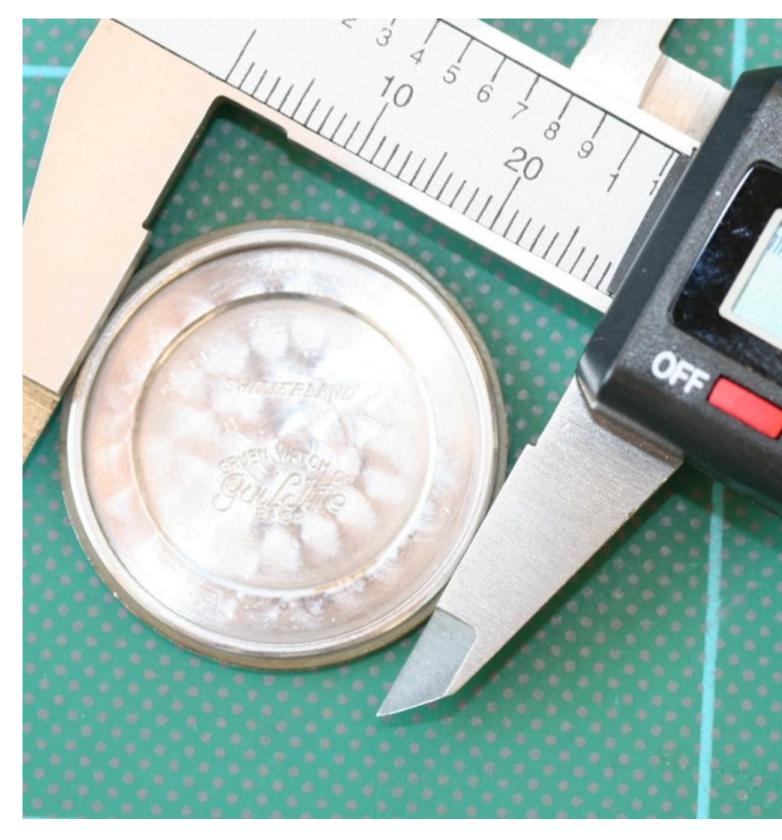
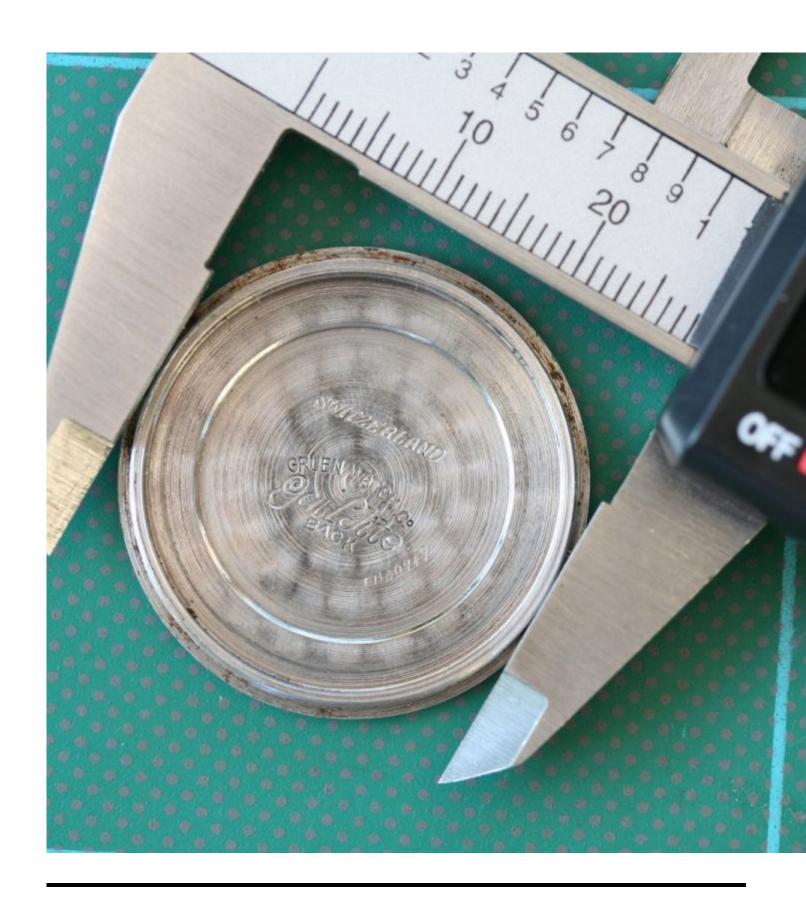
My experience is that there is a critical difference between the Gruen only and Pan American signed ones. I found this when trying to replace a bad case of a Pan America signed watch. These cases are usually strongly corroded and I bought a good non Pan American case as a replacement. Unfortunately my joy was short lived when it arrived and found there is a 3.5mm difference in the threat diameter of the case back.

Initially I thought that I was just unlucky, but over time I have measured 3 Gruen only signed case backs and 4 Gruen Pan American case backs and found the same results. Why this difference I dunno. Maybe Gruen wanted to avoid exactly what I tried to do...

So be careful, you can't swap the case backs!!
