## Subject: Fully restored all-Swiss watch with 24-hour dial Posted by JackW on Mon, 14 Dec 2015 02:26:53 GMT

So... Early Pan American styled watch in chromed basemetal bezel with stainless steel (Guildite) back.

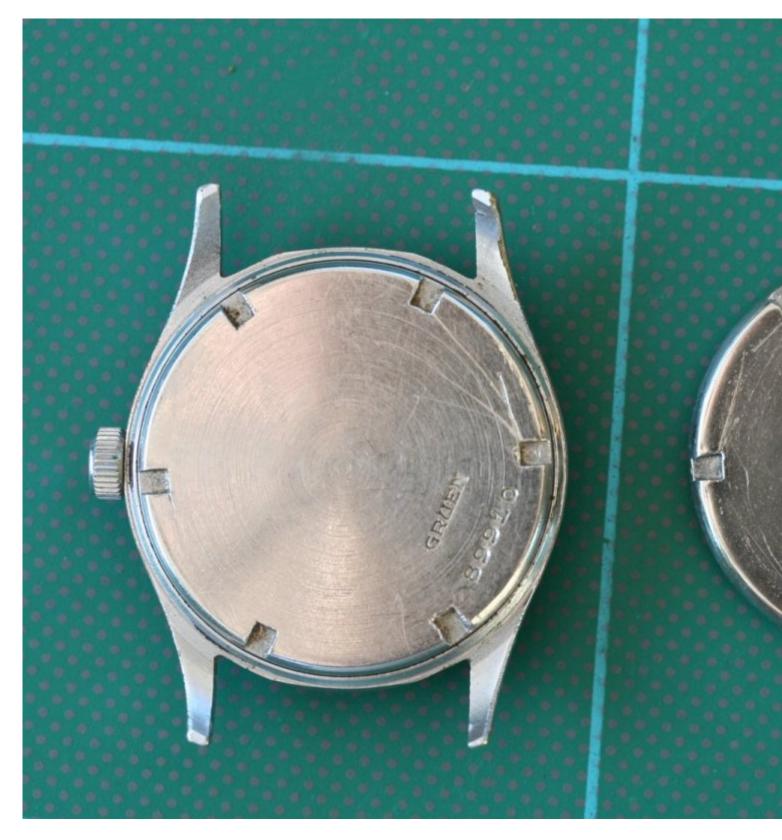
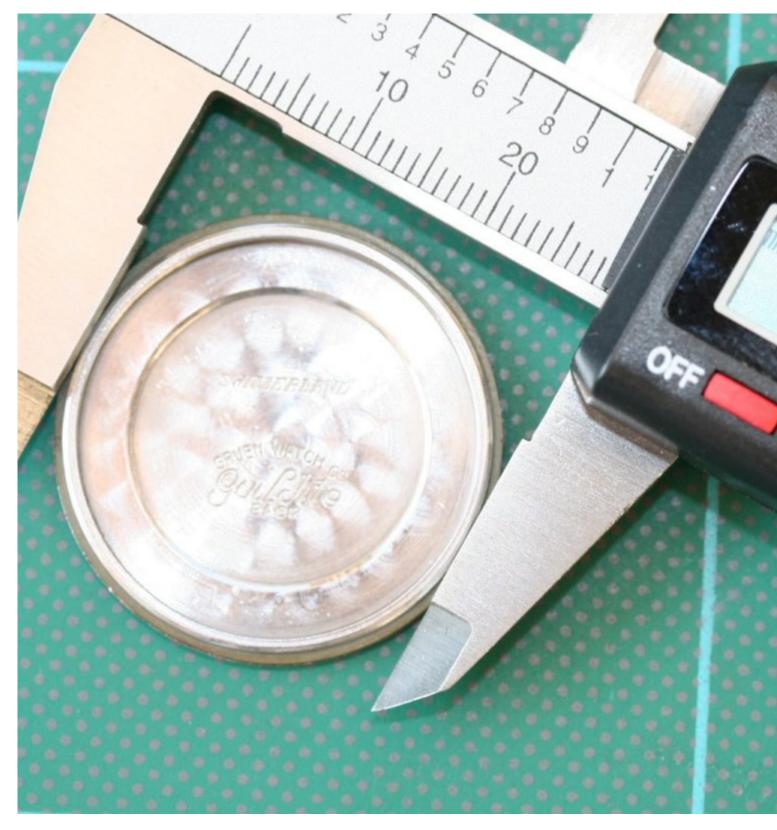
My experience is that there is a critical difference between the Gruen only and Pan American signed ones. I found this when trying to replace a bad case of a Pan America signed watch. These cases are usually strongly corroded and I bought a good non Pan American case as a replacement. Unfortunately my joy was short lived when it arrived and found there is a 3.5mm difference in the threat diameter of the case back.

Initially I thought that I was just unlucky, but over time I have measured 3 Gruen only signed case backs and 4 Gruen Pan American case backs and found the same results. Why this difference I dunno. Maybe Gruen wanted to avoid exactly what I tried to do...
