Subject: Fully restored all-Swiss watch with 24-hour dial Posted by JackW on Mon, 14 Dec 2015 02:26:53 GMT

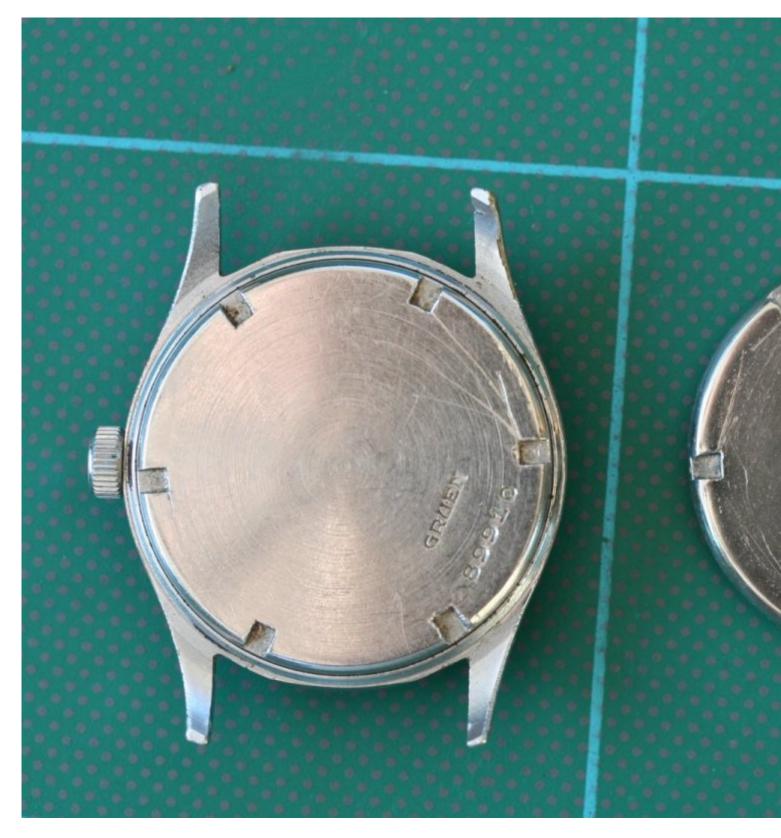
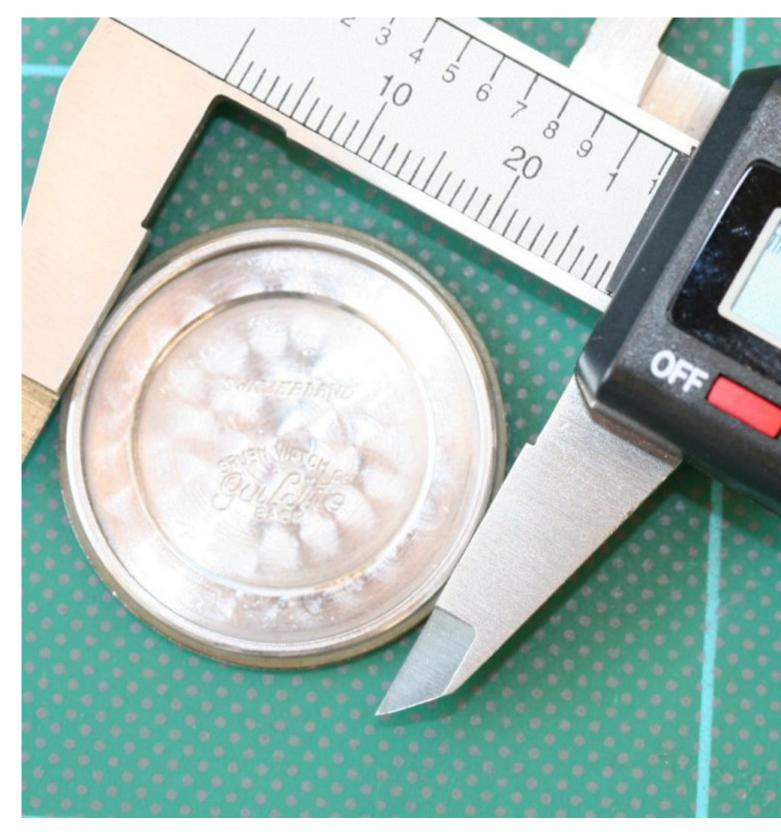
File Attachments
1) Img_3721b.jpg, downloaded 3019 times

My experience is that there is a critical difference between the Gruen only and Pan American signed ones. I found this when trying to replace a bad case of a Pan America signed watch. These cases are usually strongly corroded and I bought a good non Pan American case as a replacement. Unfortunately my joy was short lived when it arrived and found there is a 3.5mm difference in the threat diameter of the case back.

Initially I thought that I was just unlucky, but over time I have measured 3 Gruen only signed case backs and 4 Gruen Pan American case backs and found the same results. Why this difference I dunno. Maybe Gruen wanted to avoid exactly what I tried to do...

So be careful, you can't swap the case backs!!
