Subject: Fully restored all-Swiss watch with 24-hour dial Posted by JackW on Mon, 14 Dec 2015 02:26:53 GMT

So... Early Pan American styled watch in chromed basemetal bezel with stainless steel (Guildite) back.

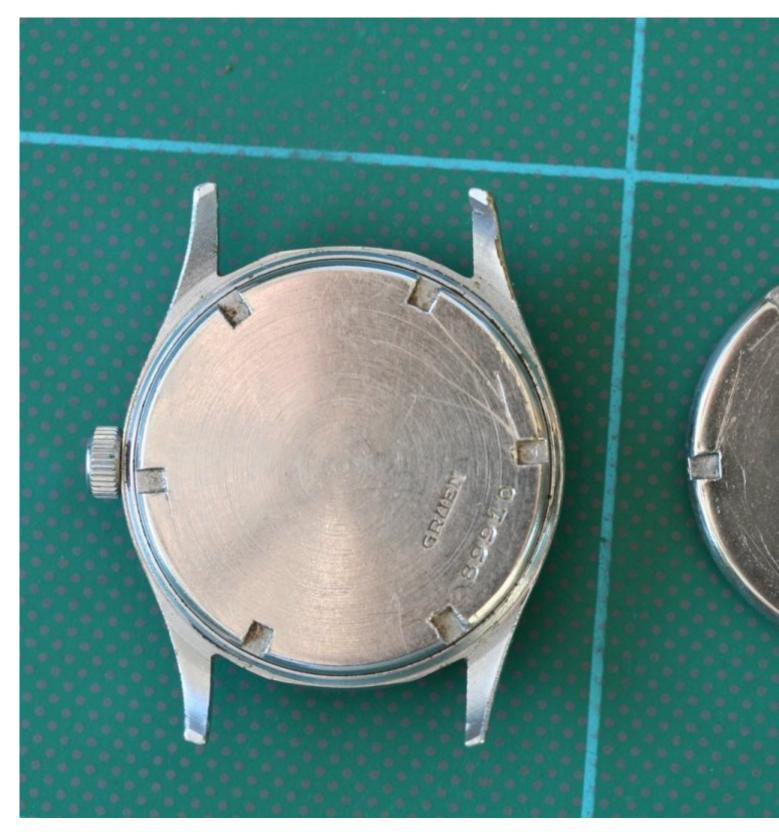
File Attachments
1) Img_3721b.jpg, downloaded 2852 times

My experience is that there is a critical difference between the Gruen only and Pan American signed ones. I found this when trying to replace a bad case of a Pan America signed watch. These cases are usually strongly corroded and I bought a good non Pan American case as a replacement. Unfortunately my joy was short lived when it arrived and found there is a 3.5mm difference in the threat diameter of the case back.

Initially I thought that I was just unlucky, but over time I have measured 3 Gruen only signed case backs and 4 Gruen Pan American case backs and found the same results. Why this difference I dunno. Maybe Gruen wanted to avoid exactly what I tried to do...

So be careful, you can't swap the case backs!!
